CRASH INJURY EVALUATION

AO-1BF MOHAWK MOCKUP

AO-1BF U. S. ARMY "MOHAWK" MOCKUP EVALUATION
Bethpage, Long Island, New York
31 March 1960

REPORT OF CRASH INJURY EVALUATION
AvCIR-12-PV-117
August 1960

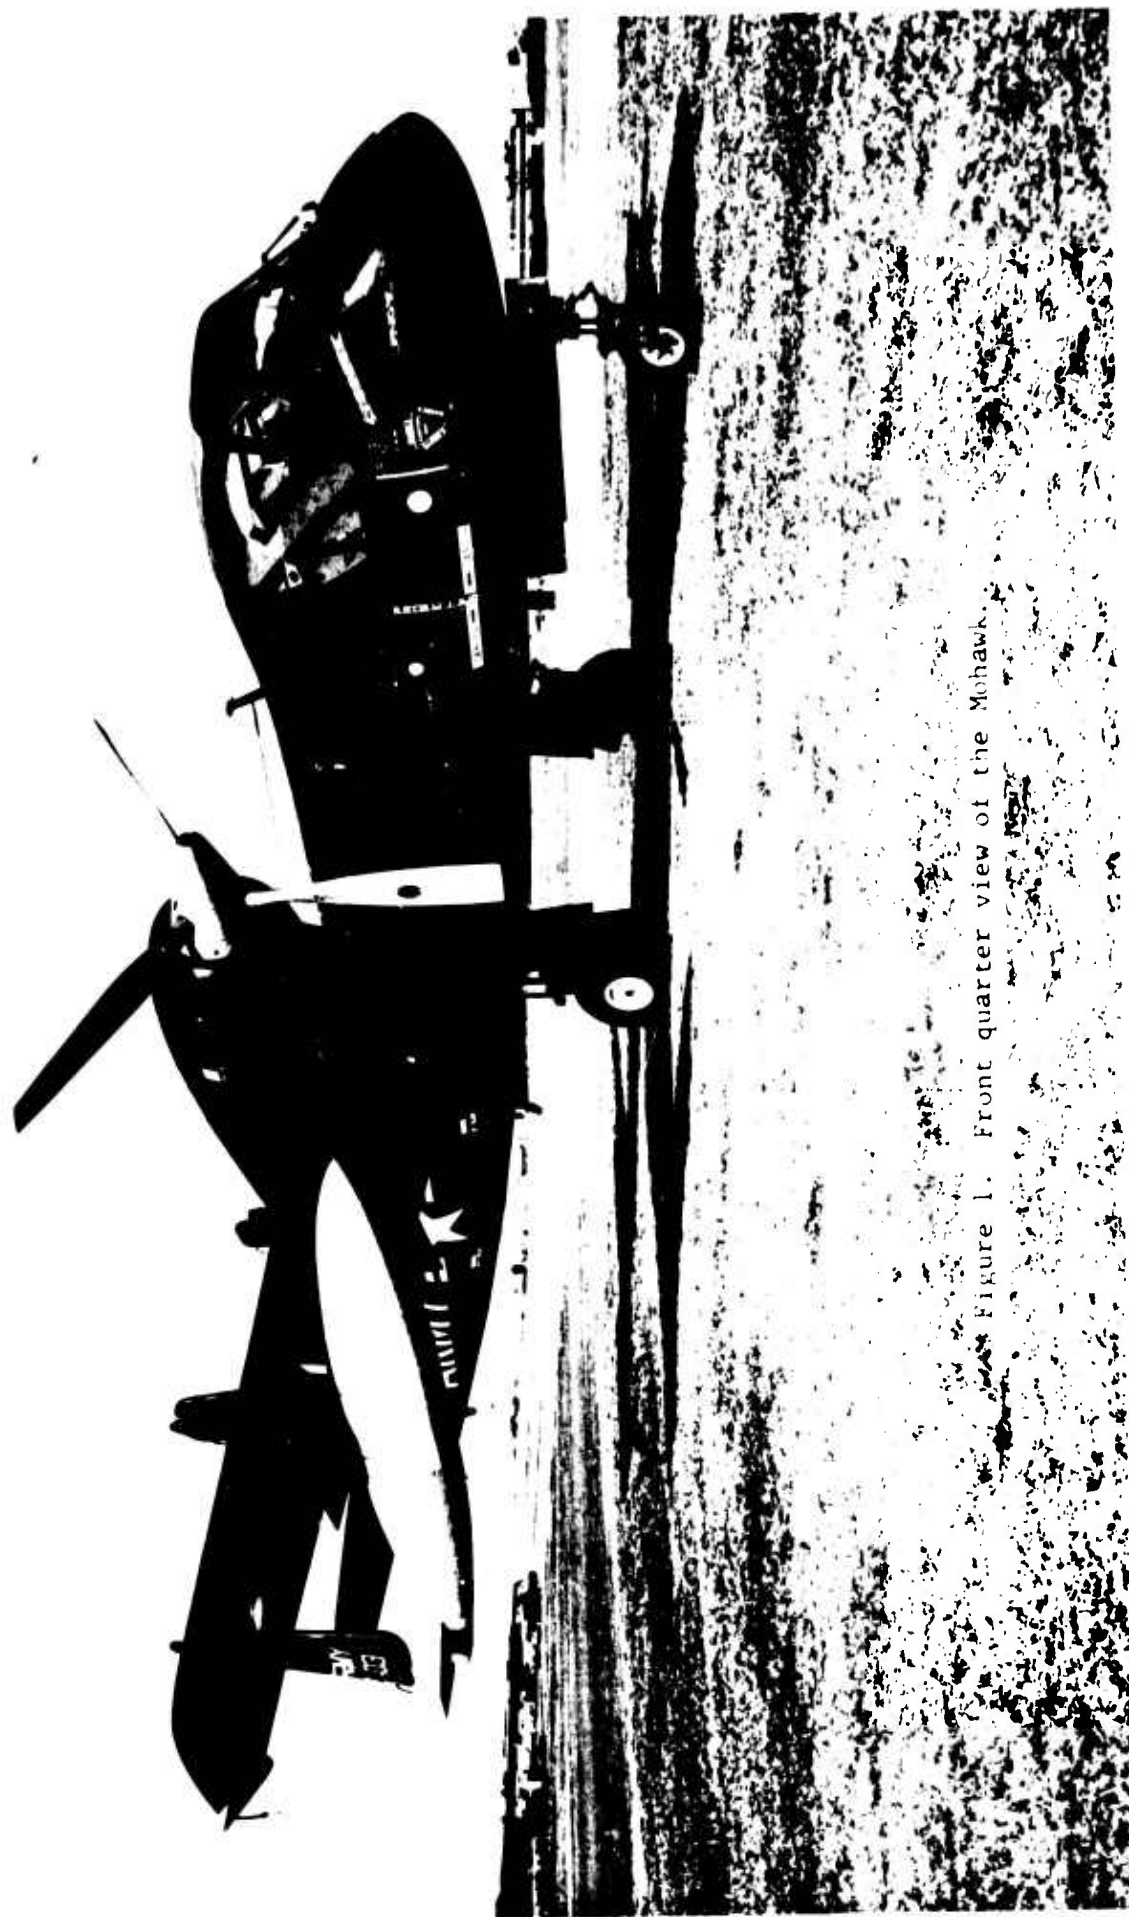
The exterior markings (Figure 1 and 6) in regard to the exit release, ejection seat, and the propeller danger area are well placed and legible from a considerable distance. The rescue arrow, upper left in this photo and also in Figure 1, pointing out the exit release, is deemed adequate for rescue personnel.

In addition to the markings mentioned above, one additional marking should be added to the aircraft which specifies the location of the hand fire extinguisher. Fire and crash trucks are not always readily available; therefore, the time spent trying to locate the fire extinguisher might prove costly in the event of a post-crash fire.

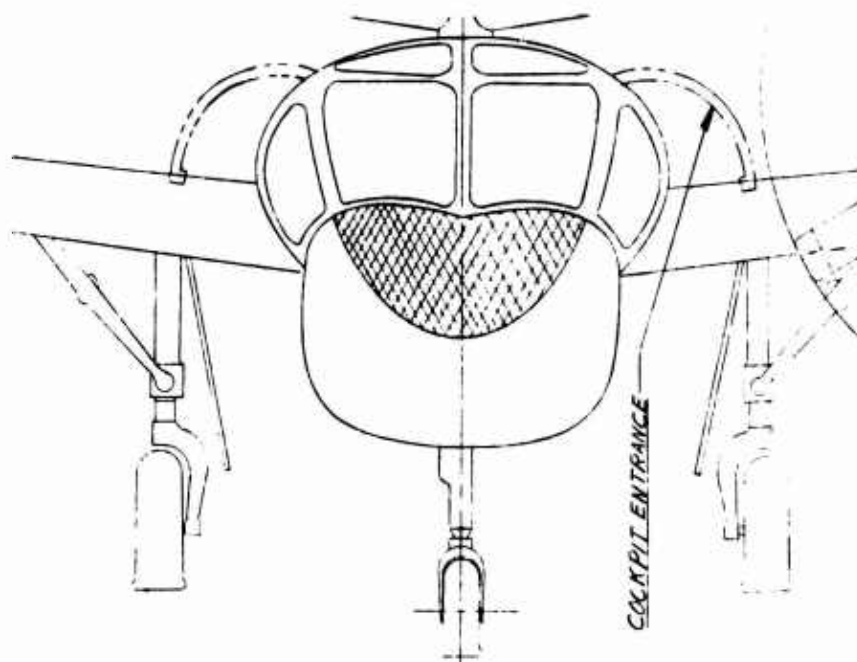
The open cockpit side entrances are depicted in Figure 9. These side panels are presently hinged at the top and swing outward to the position denoted by the arrow. Two steps are available on both sides to facilitate entrance and departure while the aircraft is parked. Departure while in flight is via the ejection seats. Normal entry and departure is very similar to a H-19 or H-34 helicopter. Care must be exercised, particularly by tall crew members, to avoid striking the open side panels while in the vicinity of the cockpit.

Figure 9. Front view showing cockpit side entrances. The arrow depicts the side entrances in the open position.

With the present design, it is not possible to jettison these side panels. In the event of a wheels-up or collapsed-gear landing, it would be difficult to remove any injured occupants through the limited opening presently available. To remove the occupants, with the aircraft on its belly, the injured person would have to be literally "poured" over the lower portion of the side entrance and then maneuvered downward under the open side panel or taken fore or aft along the sides of the aircraft. This method of removal would be time consuming in the event of a post-crash fire (see Appendix I) and could also intensify the degree of injury sustained by the occupant.

In view of these possibilities, it is felt that these panels should be jettisonable from both the interior and exterior to expedite and facilitate rescue operations.

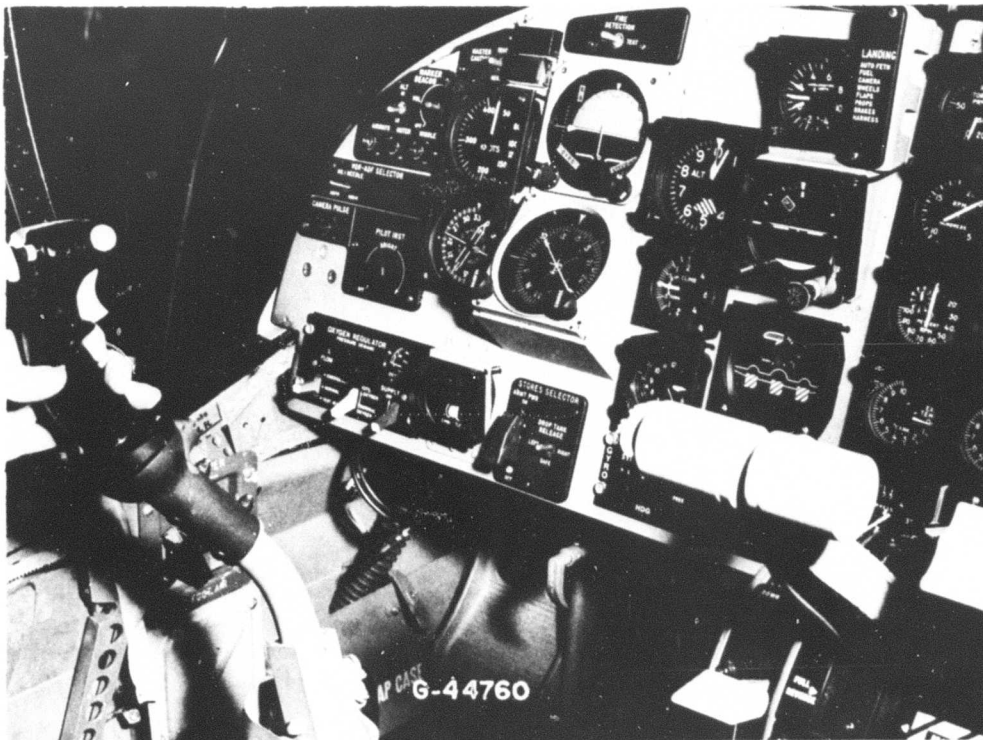
Figure 10. Close-up of the pilot's instrument panel.

The pilot's instrument panel, Figure 10, contains a large assortment of knobs, switches and protruding instruments which could produce head injuries during an accident in the event the shoulder harness and helmet were not properly utilized. A large number of sharp edges and corners are also present around the instruments. The possibility of getting all of the instruments, knobs and switches recessed or the instrument panel adequately padded is quite remote. Therefore, in order for the occupants to obtain maximum protection at all times, it must be stressed emphatically that the restraint system (safety belt and shoulder harness) plus the helmet should be utilized at all times in the prescribed manner.

The map case, located outboard of the left rudder pedal, Figure 10, appears to be an ideal location for a thermos of coffee, and it is conceivable that during turbulence or evasive maneuvers the thermos could be thrown out of the map case and jam the rudder pedals. It is suggested the map case be placarded against carrying any solid objects.

The lower portion of the instrument panel has a relatively sharp edge which could cause lower extremity injuries in the event of an accident. It is suggested that this edge be padded with energy-absorption material.

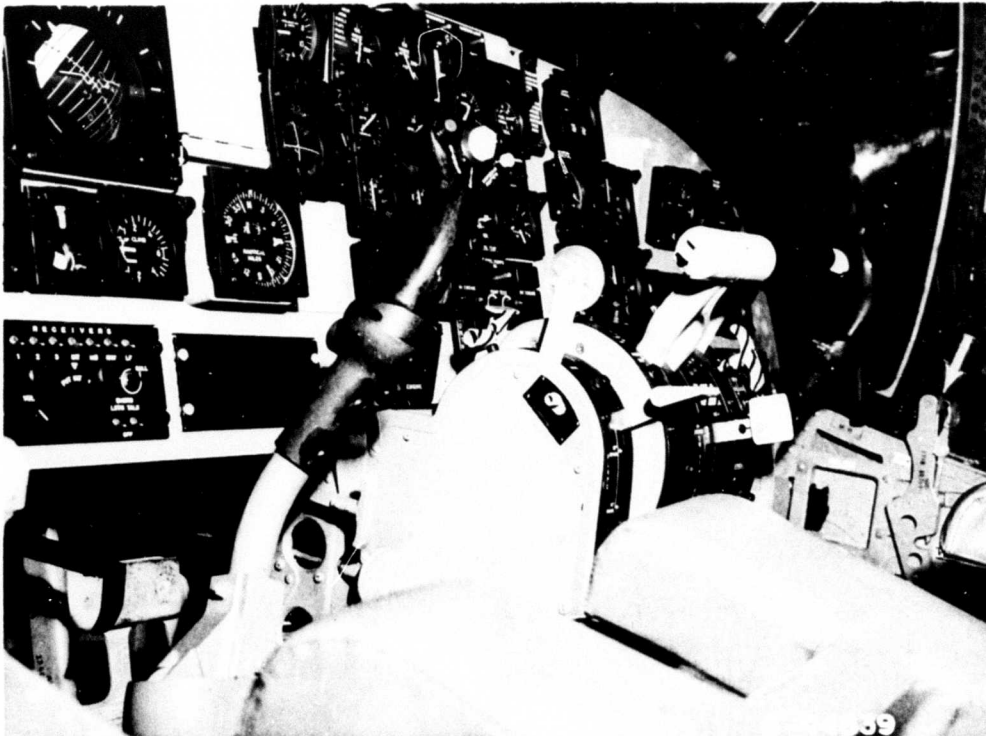
The arrow in Figure 11 denotes the side entrance opening and closing handle and is shown in the forward, or open, position. This lever, when in the locked or closed position, is directly to the left of the pilot's left arm and to the right of the other occupant's right arm and extends upward approximately three inches. This aircraft is normally flown from the left side, and it is conceivable that the pilot could catch his sleeve on this lever during violent evasive maneuvers.

Figure 11. Close-up of the instrument panel and the center pedestal. The arrow denotes the side entrance opening and closing handle.

It is suggested that a revised locking device be utilized to prevent interference by this device during flight and also while boarding the aircraft or deplaning.

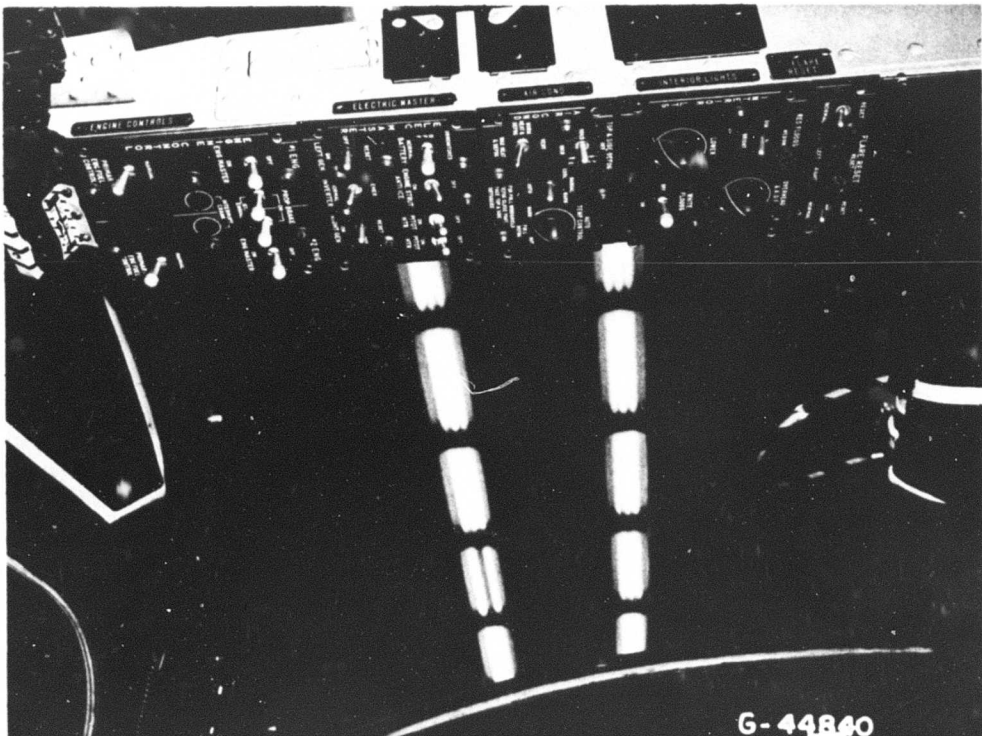
Figure 14. View of overhead console which is located between the two occupants.

Figure 14 depicts the overhead console, which is located between the two occupants. When the heads of the occupants are improperly restrained, they are within striking range of the console. Again, the possibility of getting these knobs and switches recessed is remote; therefore, it must be re-emphasized that the safety belt, shoulder harness and helmet should be worn in the prescribed manner at all times.

It should also be noted that the edges of this overhead console are quite sharp and could also produce injuries to the head in the event they were struck. It is therefore suggested that these edges be padded with a high energy-absorbing material.

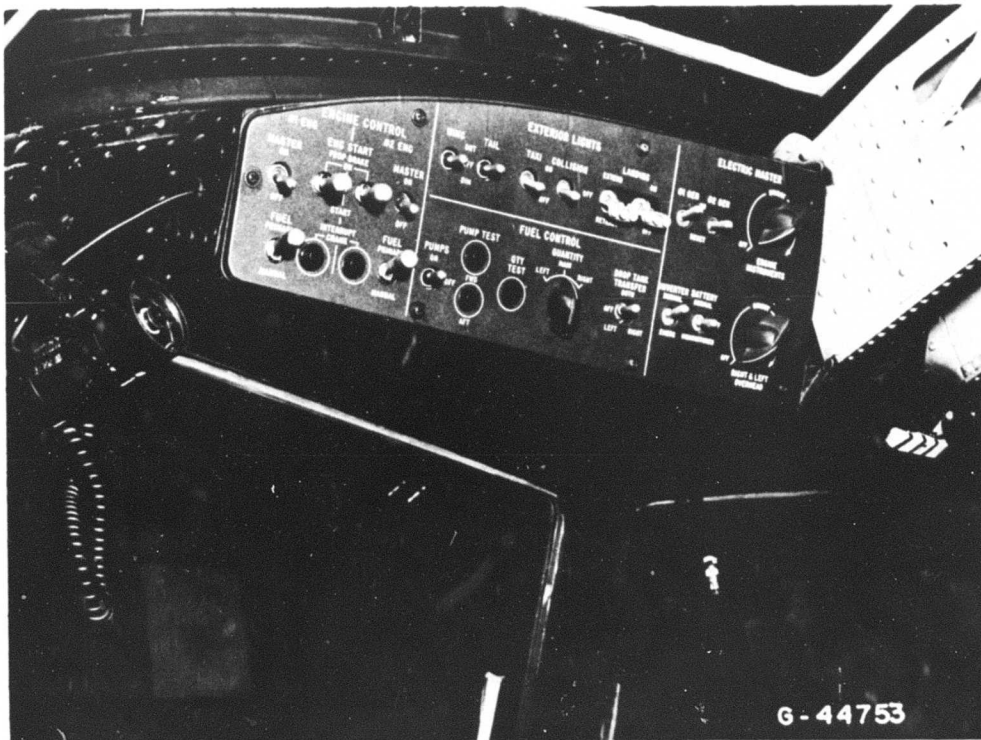
Figure 15. The left eyebrow panel is depicted.

Because of the addition of the electronic equipment, it was necessary to relocate some of the switches and controls. To accommodate these controls, two eyebrow panels, Figures 15 and 16, were added. These panels cover the small eyebrow windows directly above the windshield, which are depicted in Figure 9. If the restraint system and helmet are utilized, it is not likely that the occupants will strike this panel during decelerative forces. However, the lower edge of this eyebrow panel should be padded with a high-energy-absorbing material to provide protection during an ejection. It appears possible for the ejected occupant to impact this lower edge with his knee area in the event that he was not properly positioned during ejection.

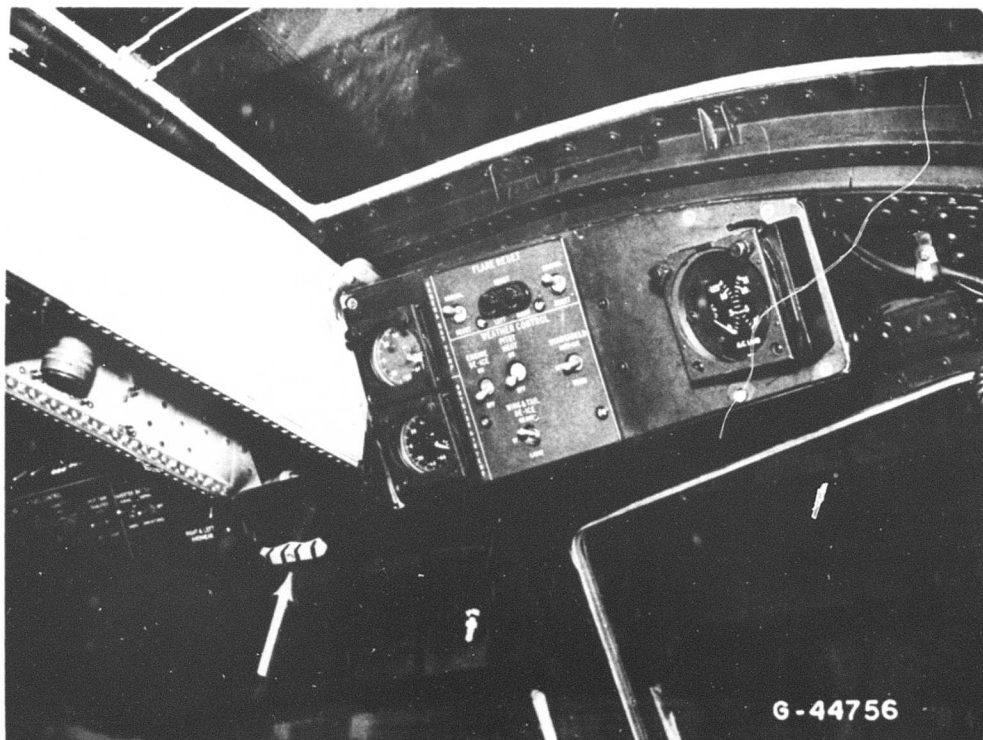
Figure 16. The arrow denotes the emergency hatch release. The right eyebrow panel is also depicted.

The overhead hatch in AO-1BF can be jettisoned from the interior only (arrow); however, this action is not a part of the firing sequence during an ejection. Normal ejection in the Mohawk is upward through the overhead canopy. Grumman advises that this method is safer than blowing off the canopy, because if the canopy jammed and was only partially blown off, the pilot's head might contact a structural bow on the canopy, which could cause fatal injury.

It is suggested that this overhead hatch be jettisonable from both the interior and the exterior to provide an additional entrance into the cockpit area for rescue personnel.

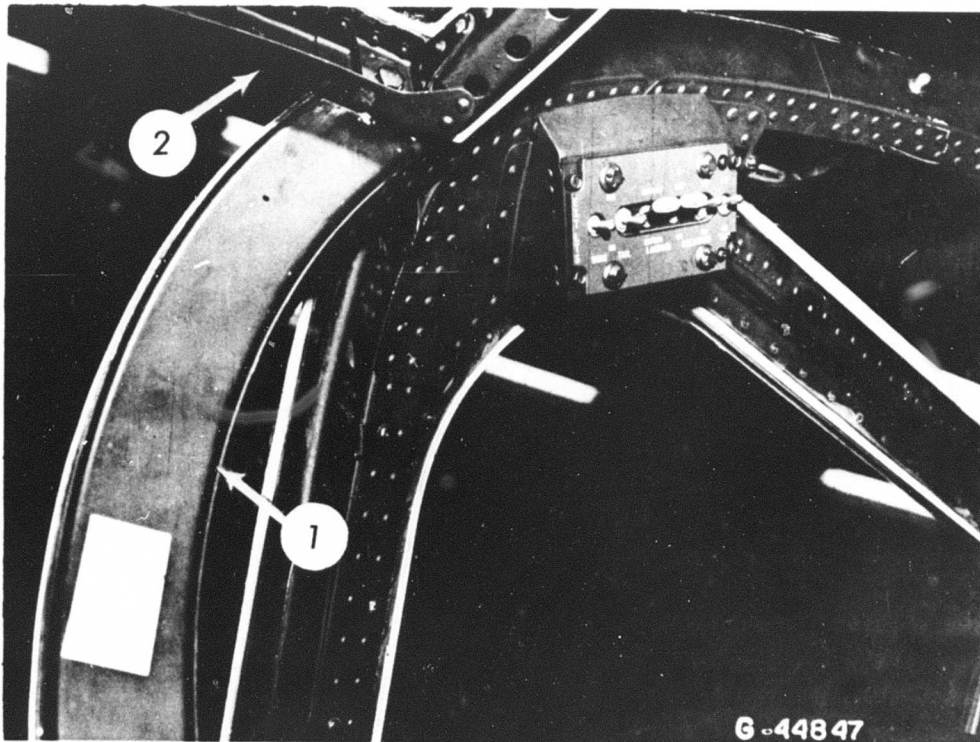
In order to build a cockpit to withstand 40 G, a rugged structure is necessary. Some of this ruggedness is depicted in Figure 17. The heavy structure surrounding the cockpit entrance is depicted by arrow 1, while arrow 2 denotes the entrance hatch in the open position. The sharp edges on the entrance hatch, arrow 2, could cause a very serious injury in the event they were struck.

Figure 17. The sharp injury-producing edges on the side panels are denoted by the arrows.

It is suggested that these two injury potential areas be padded with a high-energy-absorption material.
